Tamarack Allotment

Hydrology Report

Joy Archuleta
Umatilla Forest Hydrologist

Heppner Ranger District
Umatilla National Forest

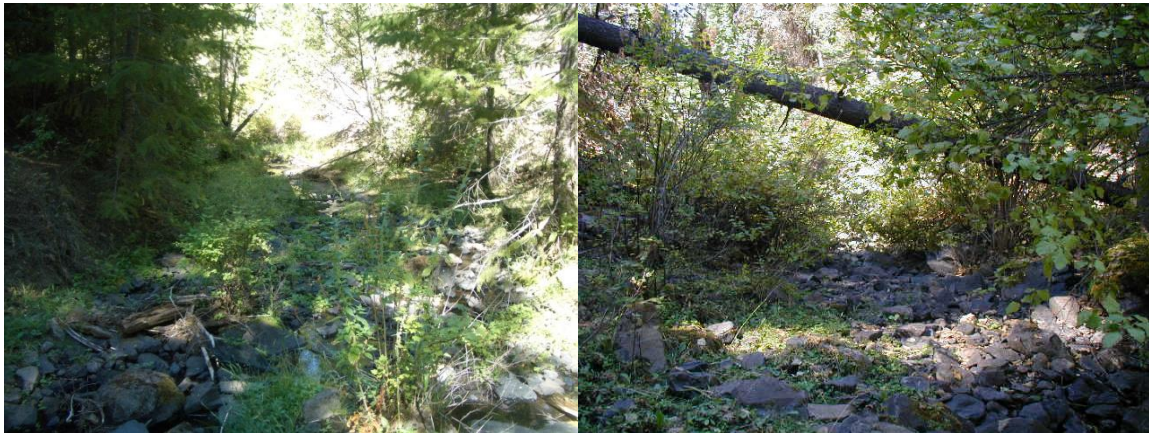
These photo points were taken as part of the PIBO implementation monitoring. Figures 1 are photographs taken at key areas/DMA at the end of the grazing season. Figure 2 presents two additional representative end-of-season photos taken in 2011 on South Fork Wall Creek in the Wildhorse Pasture. These areas are representative of the streams in the Tamarack Allotment where livestock use or overuse would first become evident. These photos, in conjunction with monitoring data, demonstrate that current management is consistently not exceeding implementation (allowable use) standards in riparian areas.

Figure 1: 2010 end of season photographs at the Tamarack Creek DMA in the Stalling Butte Pasture.

Figures 1 & 2 in the previous Existing Condition discussion were taken at key areas/DMA at the end of the grazing season. These areas represent the streams in the Tamarack Allotment where livestock use or overuse would first become evident. Changes in grazing management

after the 1990 Forest Plan and PACFISH (USDA, USDI, 1995) have resulted in improving riparian conditions in the fenced reaches. These photos, in conjunction with monitoring data, demonstrate that current management is consistently not exceeding implementation (allowable use) standards in riparian areas. Effects on the water quality parameters of stream temperature, DO and pH are anticipated to be static under this alternative reflecting current management.

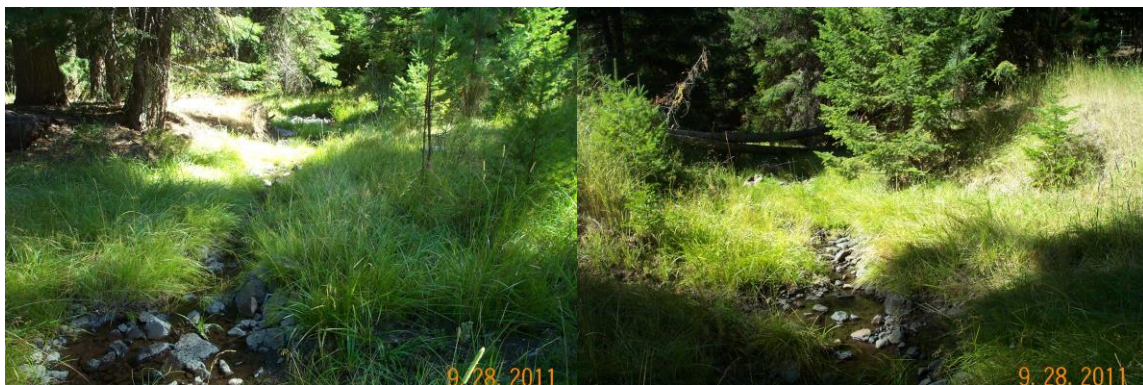
Figure 2: 2011 end of season photographs of South Fork Wall Creek in the Wildhorse Pasture.

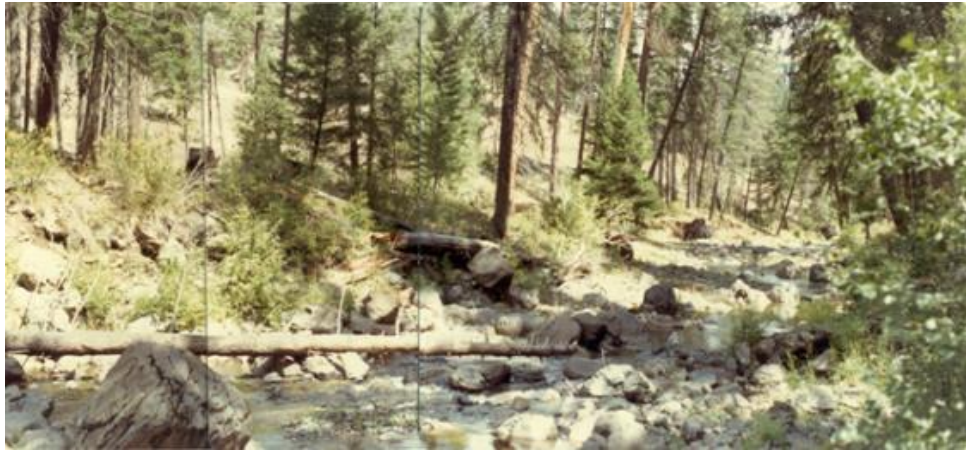
As evidenced by monitoring data and photos the riparian areas are continuing to recover since the mid 1970's (*Figures 3 & 4*). The photos below were taken in the Hardman Allotment just downstream in Big Wall Creek. These photos are indicative of the change in riparian conditions within the Tamarack allotment along fenced perennial streams between 1976 and 2003. Changes in grazing management after the 1990 Forest Plan and PACFISH (USDA & USDI, 1995) have resulted in improving riparian conditions.

Figure 3: Big Wall Creek in the Monument Allotment in 1976.

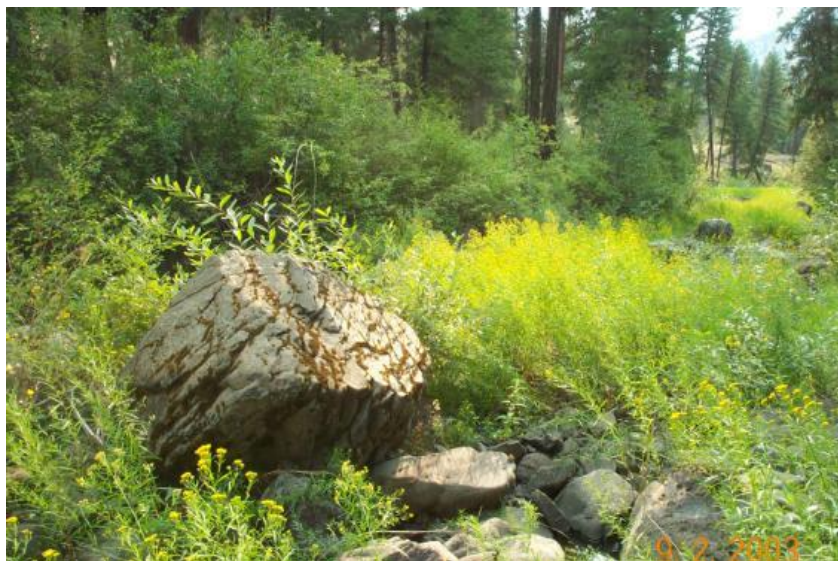
Figure 4: Big Wall Creek in the Monument Allotment in 2003.
